## Solución DM858 medir 33v DC

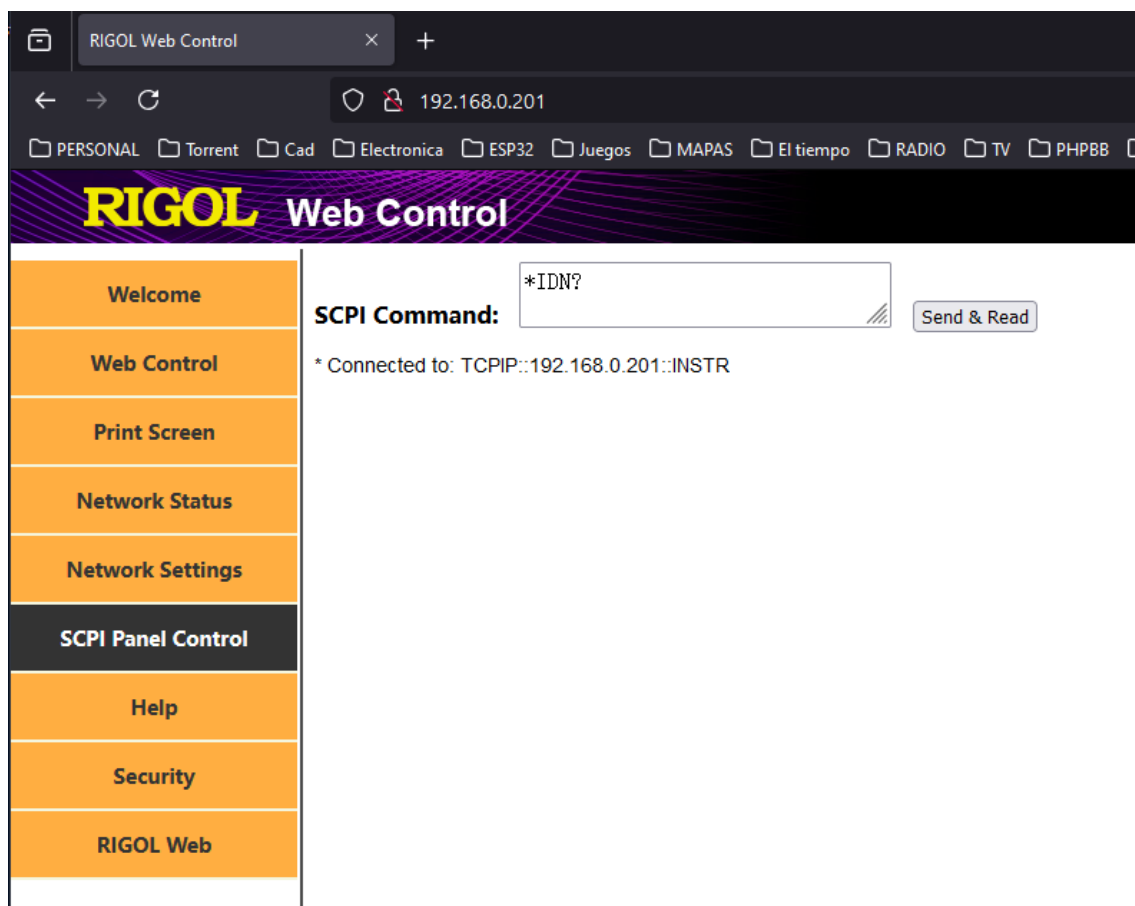
Lo instalamos, detectamos el multímetro, en mi caso en LAN, y conectas vía SCPI para introducir los comandos en cuestión, **SYSTEM:CFGVER?** Que retornara un valor, en mi caso 2, y **SYSTEM:CFGVER 1** para poner ese valor, muy importante reiniciar el equipo después, y cuando arranque ya medirá correctamente los 33v DC

Este proceso también puede hacerse desde el Web Control
